NAVISTAR, INC

DEFECT INFORMATION REPORT

REPORT ID: 15-I6-12000801-01
Revision.: -
Ref. Investigation.: -
Ref. AFC:-
Ref. VER:- 15515

This report addresses a calibration defect regarding the Electronic Control Module (ECM).

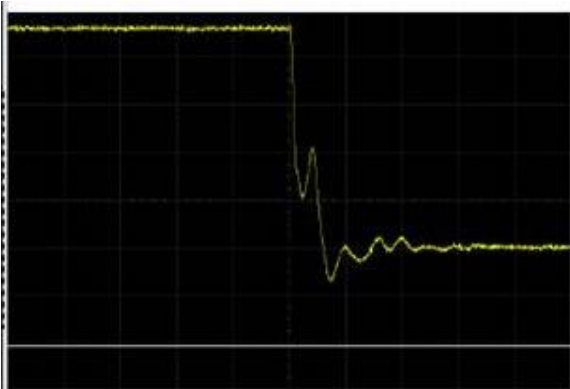
Navistar certified N9 and N10 engines with SCR aftertreatment for the 2014 model year. To help reduce CPU loading of the ECM the clock frequency was increased from 56 MHz to 64MHz. When the clock frequency was increased the clock signal slew rate was also increased (mistakenly). The increased slew rate caused “ringing” of the clock signal which in turn caused read errors to occur in the ECM and ultimately memory corruption (reference left photo below). When the clock slew rate was slowed to the original rate the ringing was completely eliminated (reference right photo below) along with the read errors and occurrences of memory corruption.

Current situation: Without Slew Rate Control or fast slew rate (Frequency 1 MHz)

The memory corruption occurred most often at low ambient temperatures. This caused the ECM to set fault code 629/12 indicating an “internal chip error”, and illuminating the MIL resulting in replacement of the ECM.

Navistar intends to perform a voluntary emissions recall (#15515), consisting of a new ECM calibration. This calibration will return the clock slew rate to the pre- 2014 MY value.

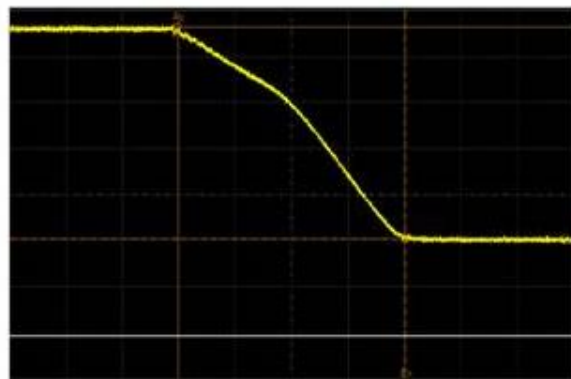
Solution: With Slew Rate Control or slow slew rate (Frequency 1 MHz)
